New York State Department of Transportation

Yellow Flag NB2358W006

BIN: 1065318

Location: Span 29, Girder G17 at Pier 29 above the right lane of 65th Street EB roadway between 4th and 5th Avenue.

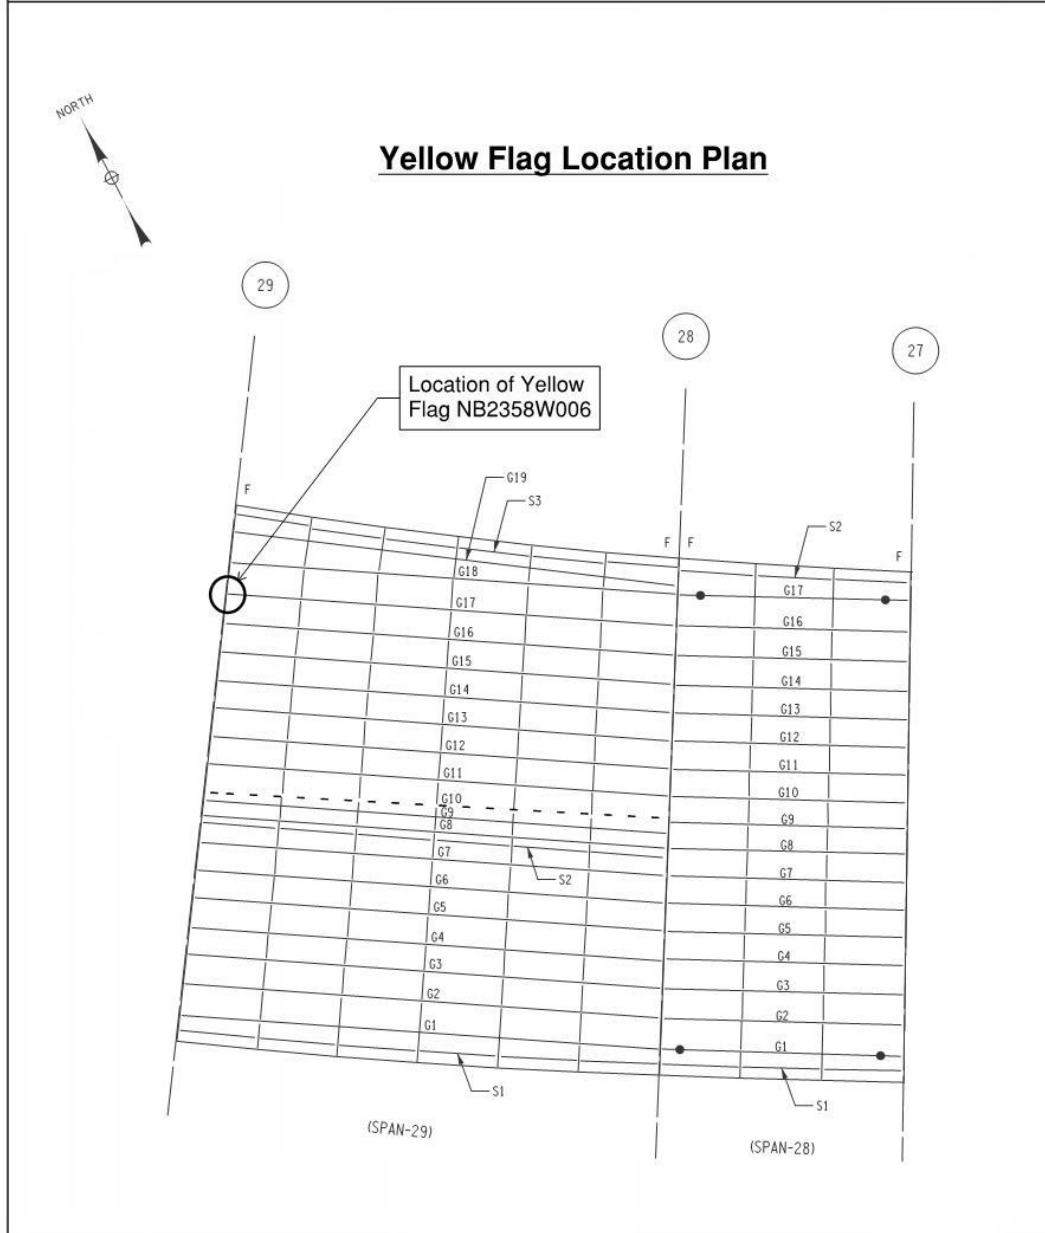
Flag PhotographsPhoto Number: **1**Photo Filename: **23_Flag Location Plan.jpg**Gowanus Expressway
2023 Biennial Inspection - Field SketchBIN: 1065318Team: AA/TSDate: 04/24/2023Span: 29Location: Girder G17 at Pier 29

**Attachment Description: Flag Location Plan**

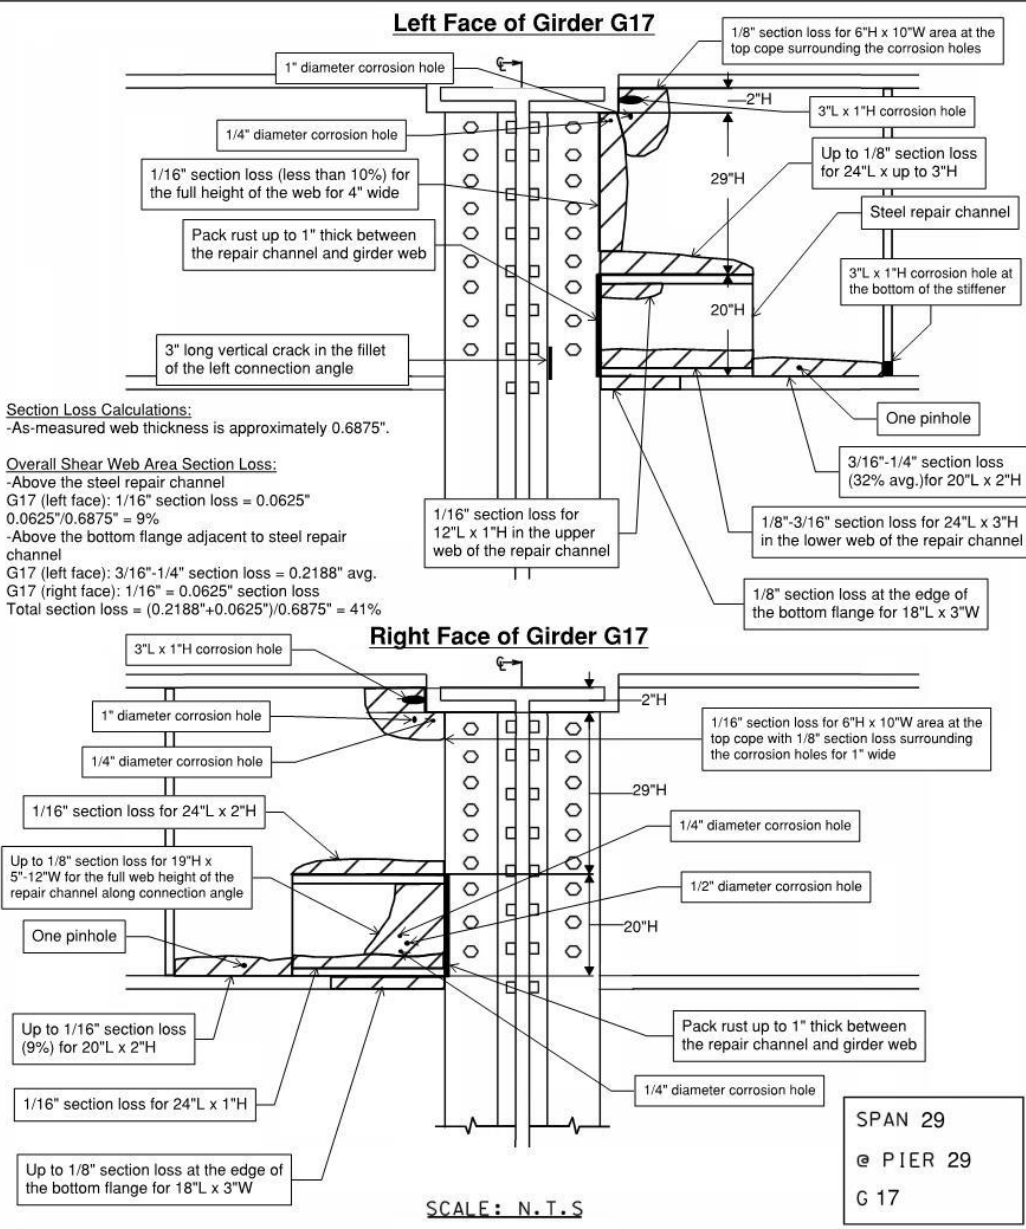
Photo Number: 2

In addition, there is a previous repair channel at the lower web, above the bottom flange. Full height section loss in the shear web area of the girder above the repair channel is 1/16" (less than 10%), Localized section loss in the lower web of the girder, above the bottom flange and adjacent to the repair channel is 3/16"-1/4" deep section loss (32% avg.) for 20" L x 2" H at the left face and up to 1/16" deep section loss (9%) for 20" L x 2" H at the right face for an approximately 41% localized section loss over a 20" L x 2" H area.(refer to Yellow Flag Condition sketch #2 for more details).

Attachment Description: Flag Condition Sketch

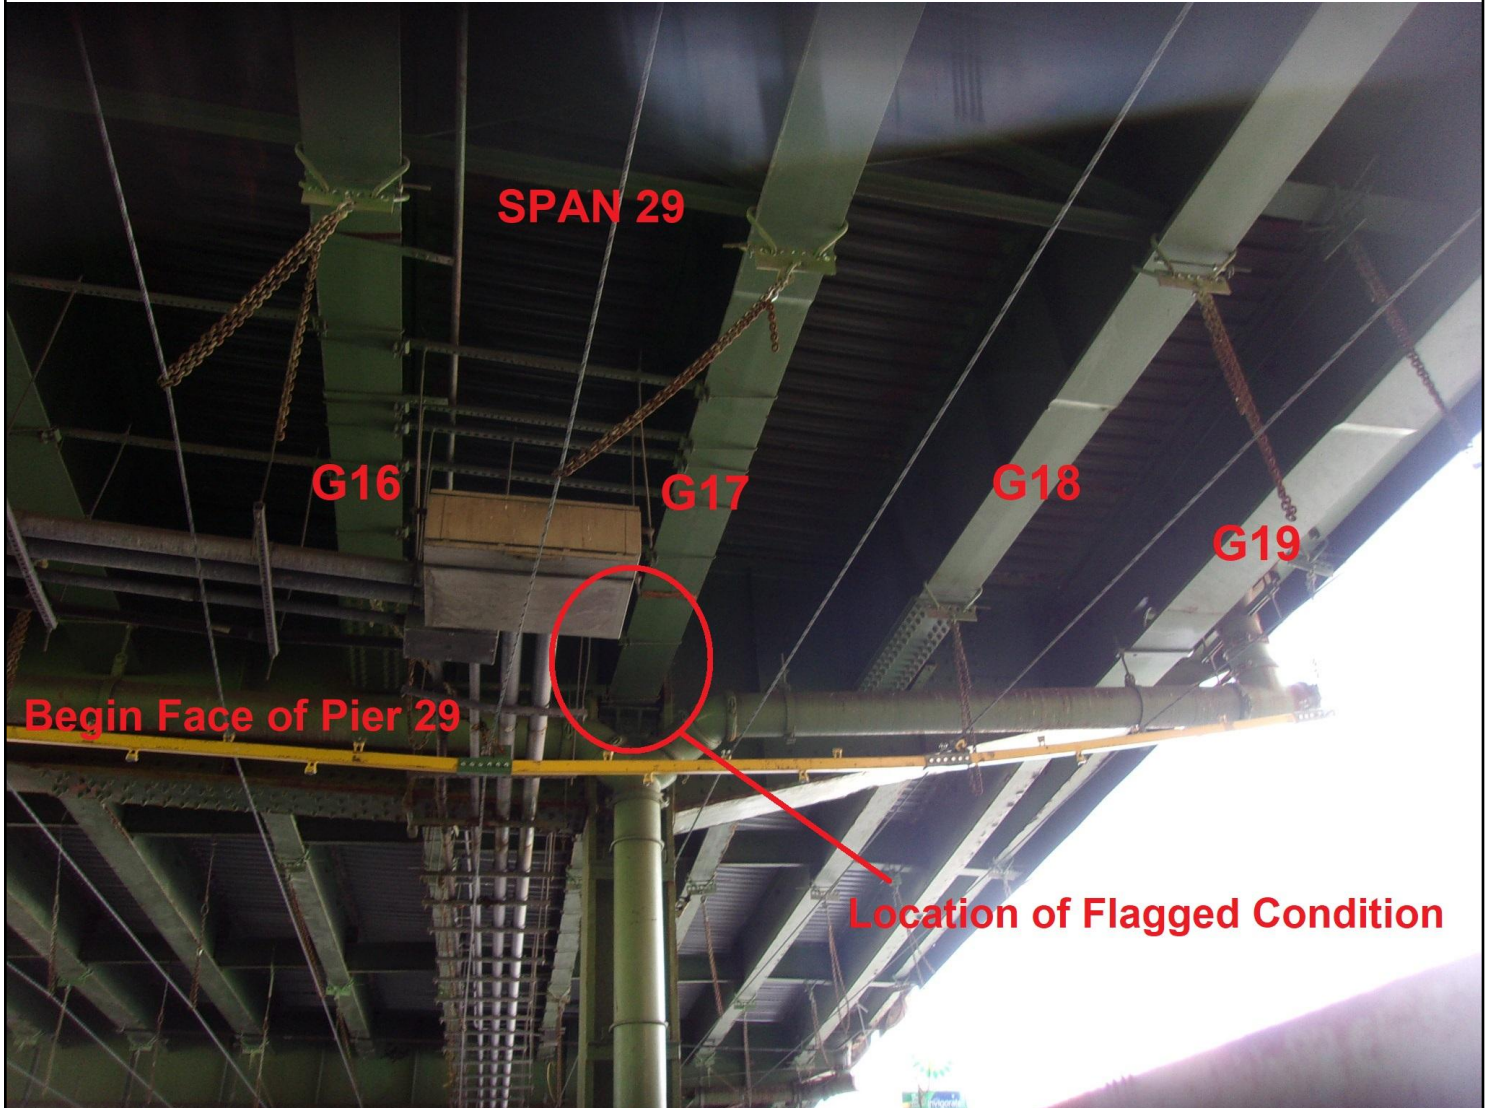
Photo Number: 3

Attachment Description: General view of the flagged condition at Girder G17 in Span 29 at Pier 29. Looking End.

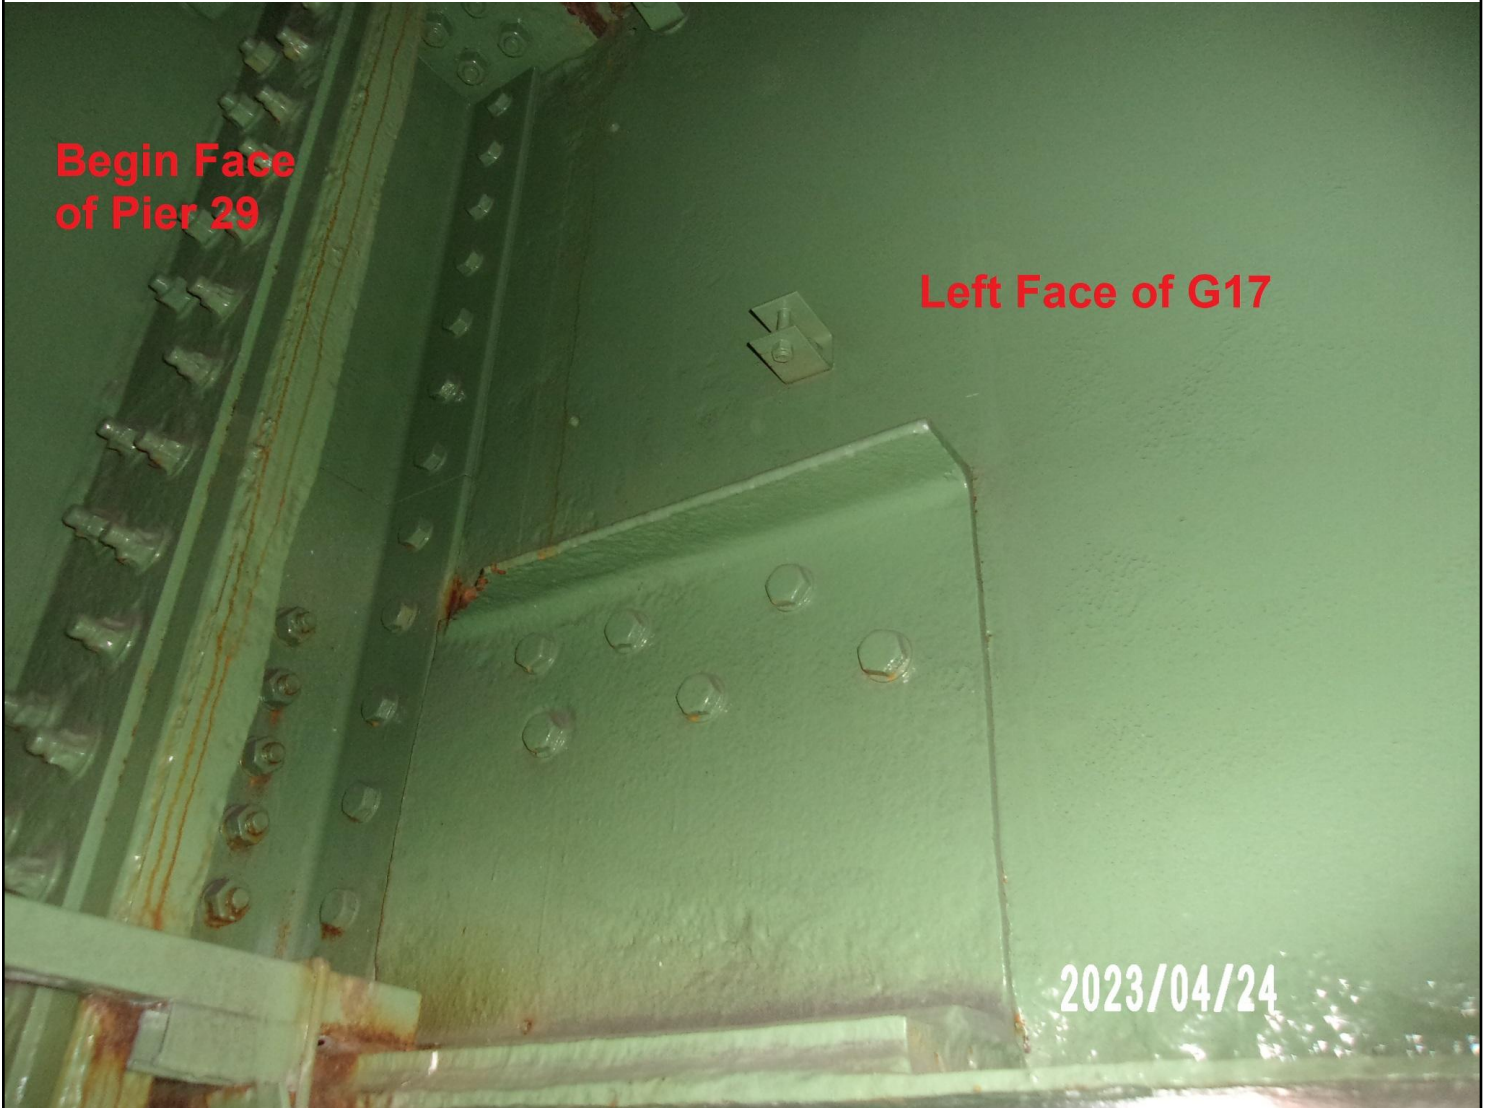
Photo Number: 4

Attachment Description: Close up general view of the left face of Girder G17 in Span 29 at Pier 29. Looking End and Right.

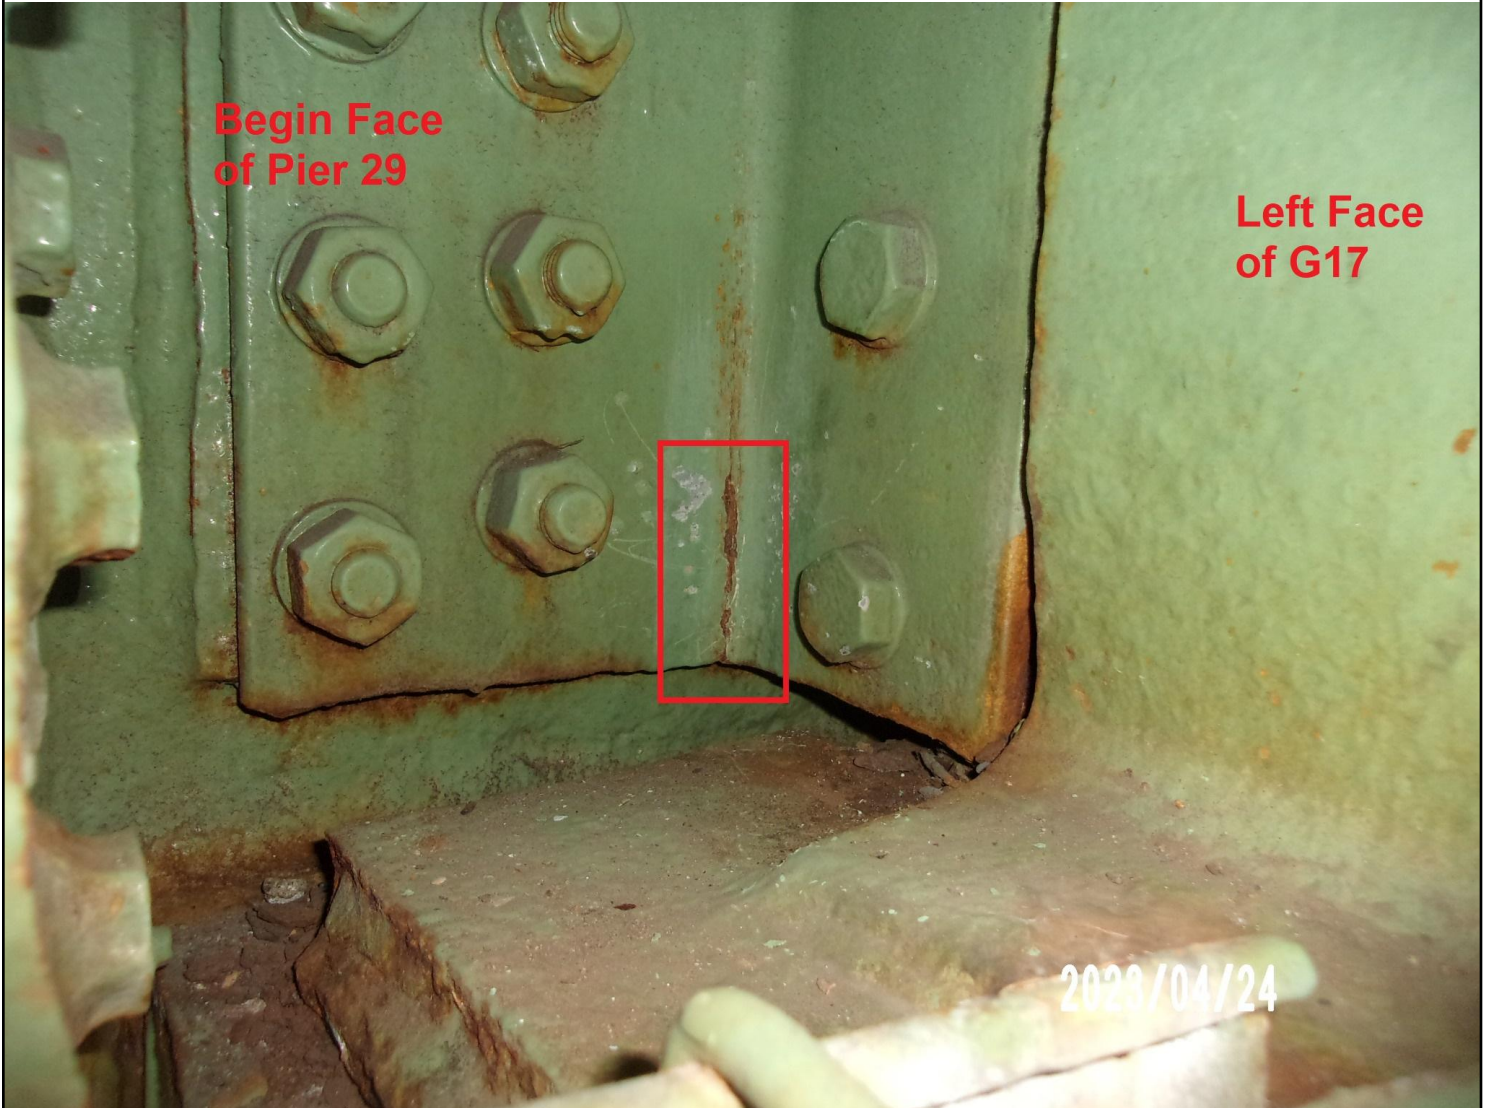
Photo Number: 5

The end of Girder G17 on Span 29 Side of Pier 29 exhibits 3" long vertical crack in the fillet of the left connection angle starting at the bottom of the connection angle. (Photos #5 and #6).

Attachment Description: The left face of Girder G17 in Span 29 at Pier 29. The bottom of the left connection angle exhibits a 3" long vertical crack in the fillet of the angle (prior to Dye Penetrant test). Looking End and Right.

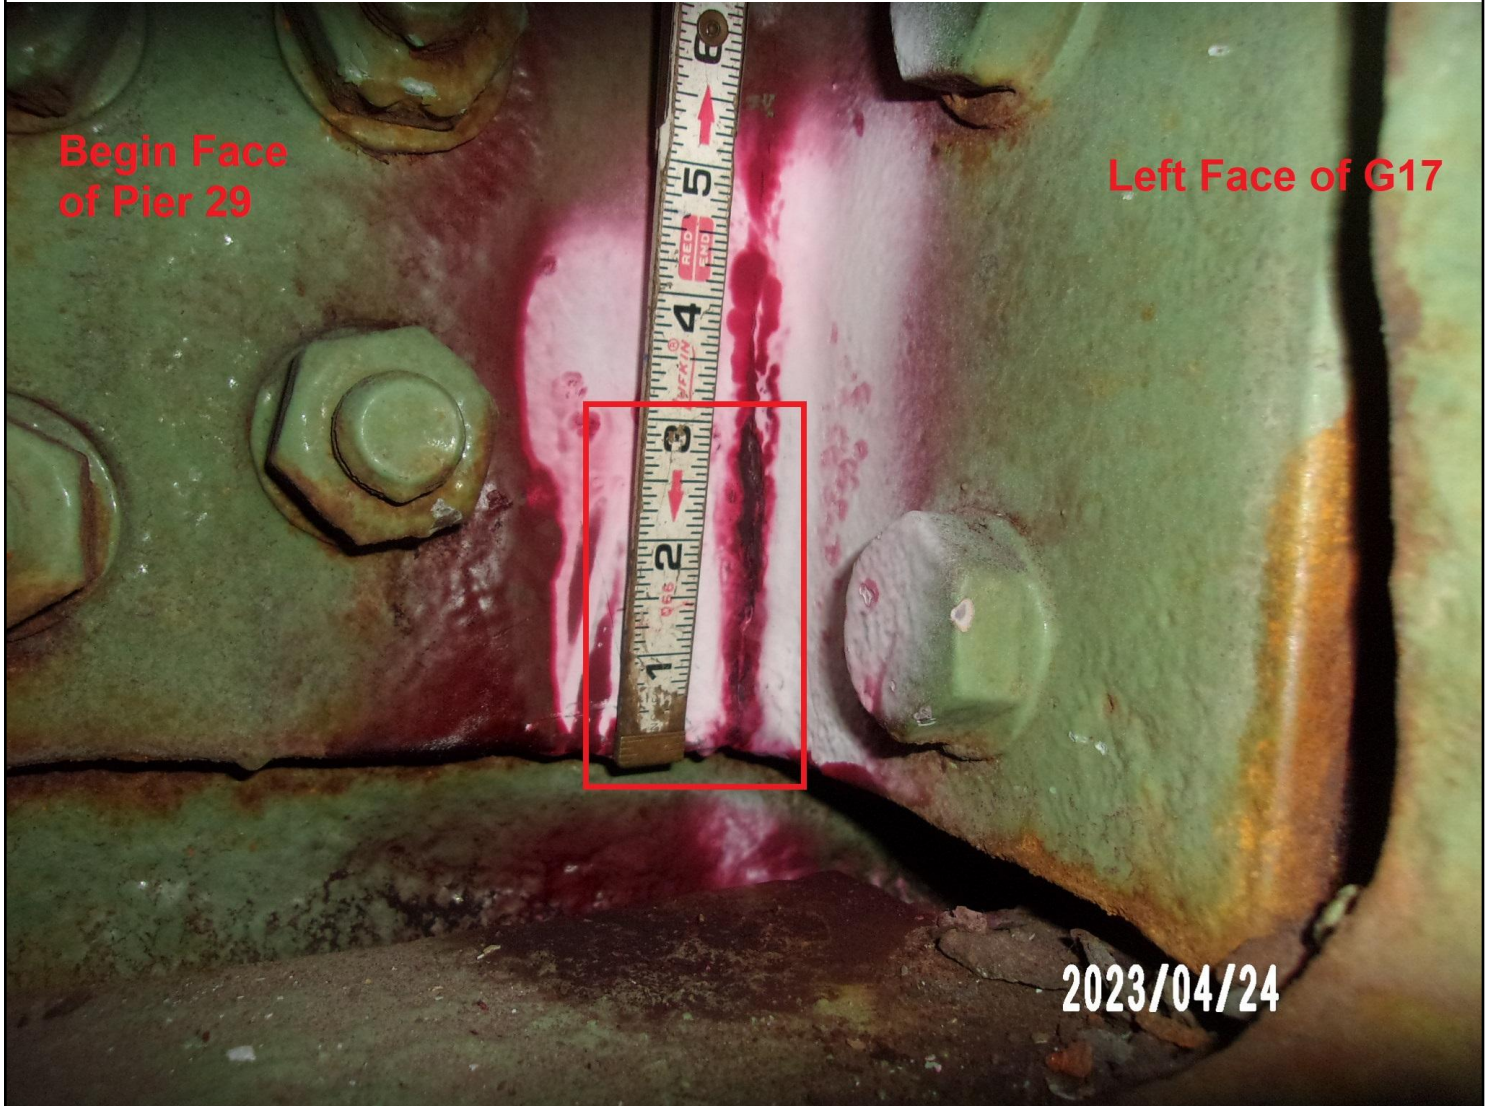
Photo Number: 6

3. Dye Penetrant test was performed to establish the limits of the crack.
- 4.This location was inspected during the 2022 SILO (no crack was present), with the following description as per the mini report:
This girder location has previously installed steel repair channel at the lower web above the bottom flange which exhibits 1/8"-3/16" deep section loss in the lower web area for 24" L (full channel length) x 3" H and 1/16" deep section loss in the upper web area for 12" L x 1" H at the left face and 1/16" deep section loss for 24" L (full channel length) x 1" H in the lower web area and up to 1/8" deep section loss for the full channel web height (19" H) x 5"-12" W along the connection angle at the right face. Also, the steel repair channel at the right face exhibits three corrosion holes with two 1/4" diameter holes and one 1/2" diameter hole within section loss area near connection angle. The girder web area at the begin side of the steel repair channel exhibits 3/16"-1/4" deep section loss for 20" L x 2" H at the left face and up to 1/16" deep section loss for 20" L x 2" H at the right face in the lower web above the bottom flange with one pin hole approximately 8" from begin side of repair channel within section loss area. The girder web above the steel repair channel exhibits section loss for up to 1/8" deep for 24" L x up to 3" H at the left face and 1/16" deep for 24" L x 2" H at the right face. In addition, the steel repair channel exhibits pack rust up to 1" thick between the channel and girder web for the full height of channel at the end side along the connection angle. The remaining girder web area exhibits 1/16" deep section loss for full web height for 4" wide along connection angle at the left face with 6" H x 10" W area at top cope with 1/8" section loss at both faces of the girder. Also, the upper web area at the top cope exhibits three corrosion holes with one 1/4" diameter hole, one 1" diameter hole, and one 3" L x 1" H hole within section loss area. The bottom flange exhibits up to 1/8" deep section loss at the edge of the flange for 18" L x 3" W at both sides. (Photos #7 thru #10) The first vertical web stiffener (counting from pier 29) exhibits 3" L x 1" H corrosion hole at the bottom of the stiffener at the left face.

Attachment Description: The left face of Girder G17 in Span 29 at Pier 29. The bottom of the left connection angle exhibits a 3" long vertical crack in the fillet of the angle (post Dye Penetrant test). Looking End and Right.

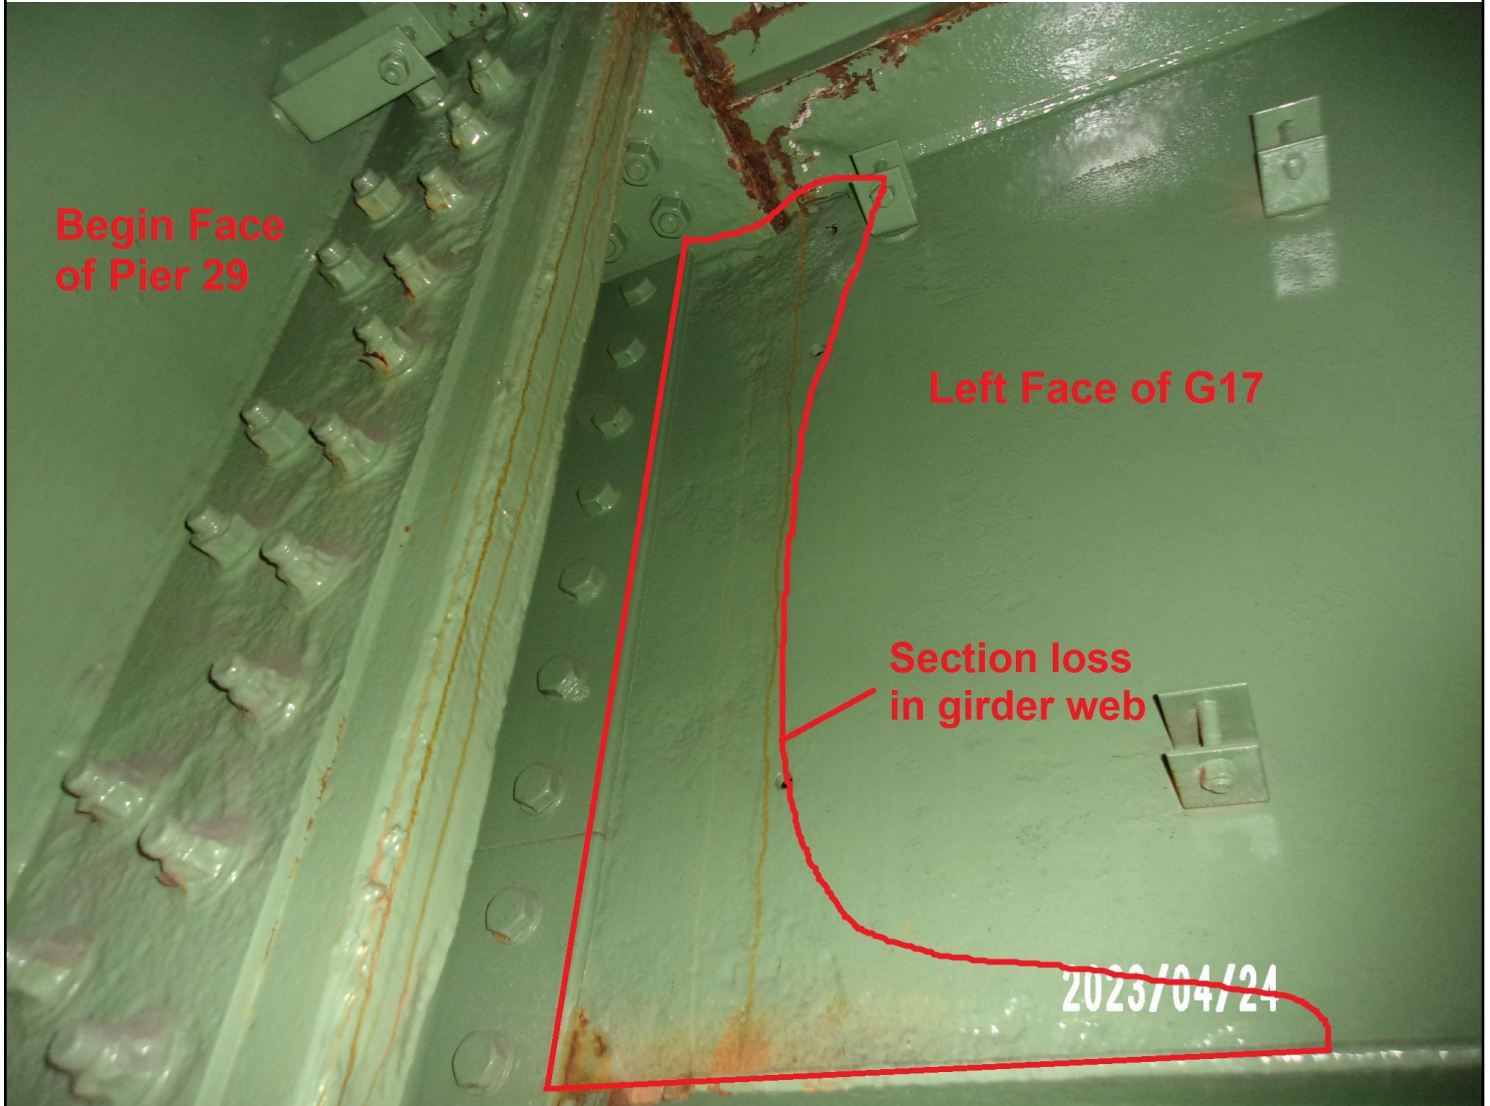
Photo Number: 7

Attachment Description: The left face of Girder G17 in Span 29 at Pier 29. The girder web above the steel repair channel exhibits section loss (less than 10%) for the full web height along the connection angle. Looking End and Right.

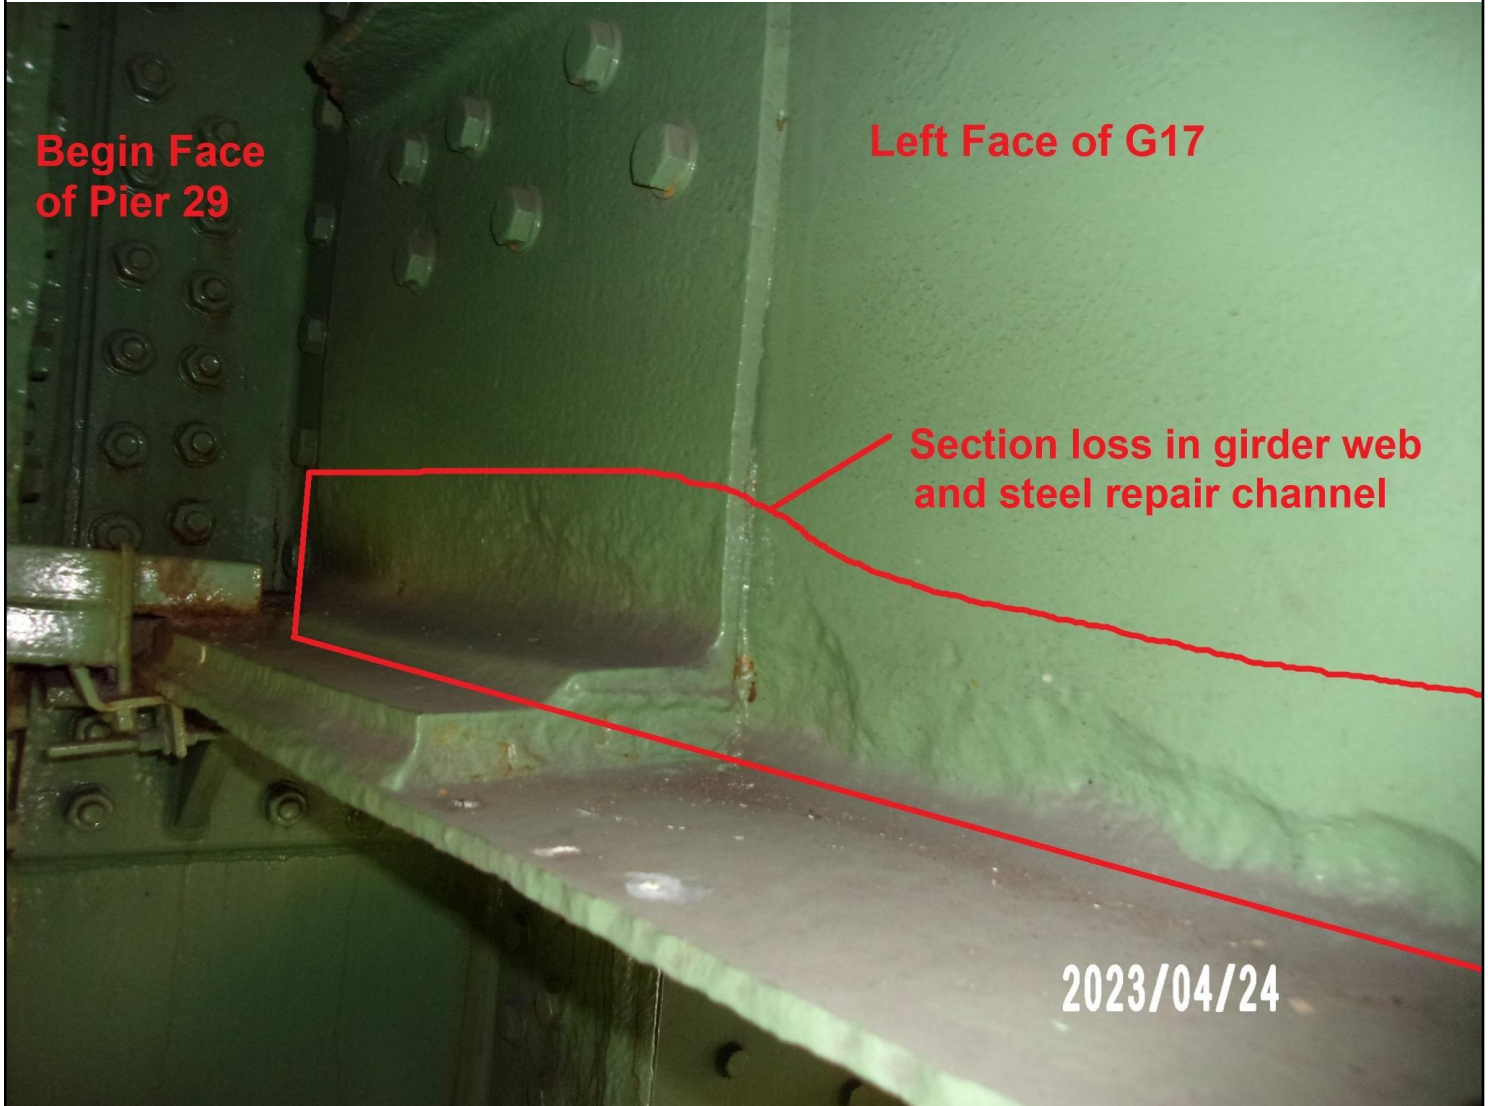
Photo Number: 8

Attachment Description: The left face of Girder G17 in Span 29 at Pier 29. The steel repair channel and girder area following the repair channel exhibits section loss in the lower web above the bottom flange. The localized loss in the lower web, adjacent to the channel is approx. 41% over an 20" L x 2" H area. Looking End and Right.

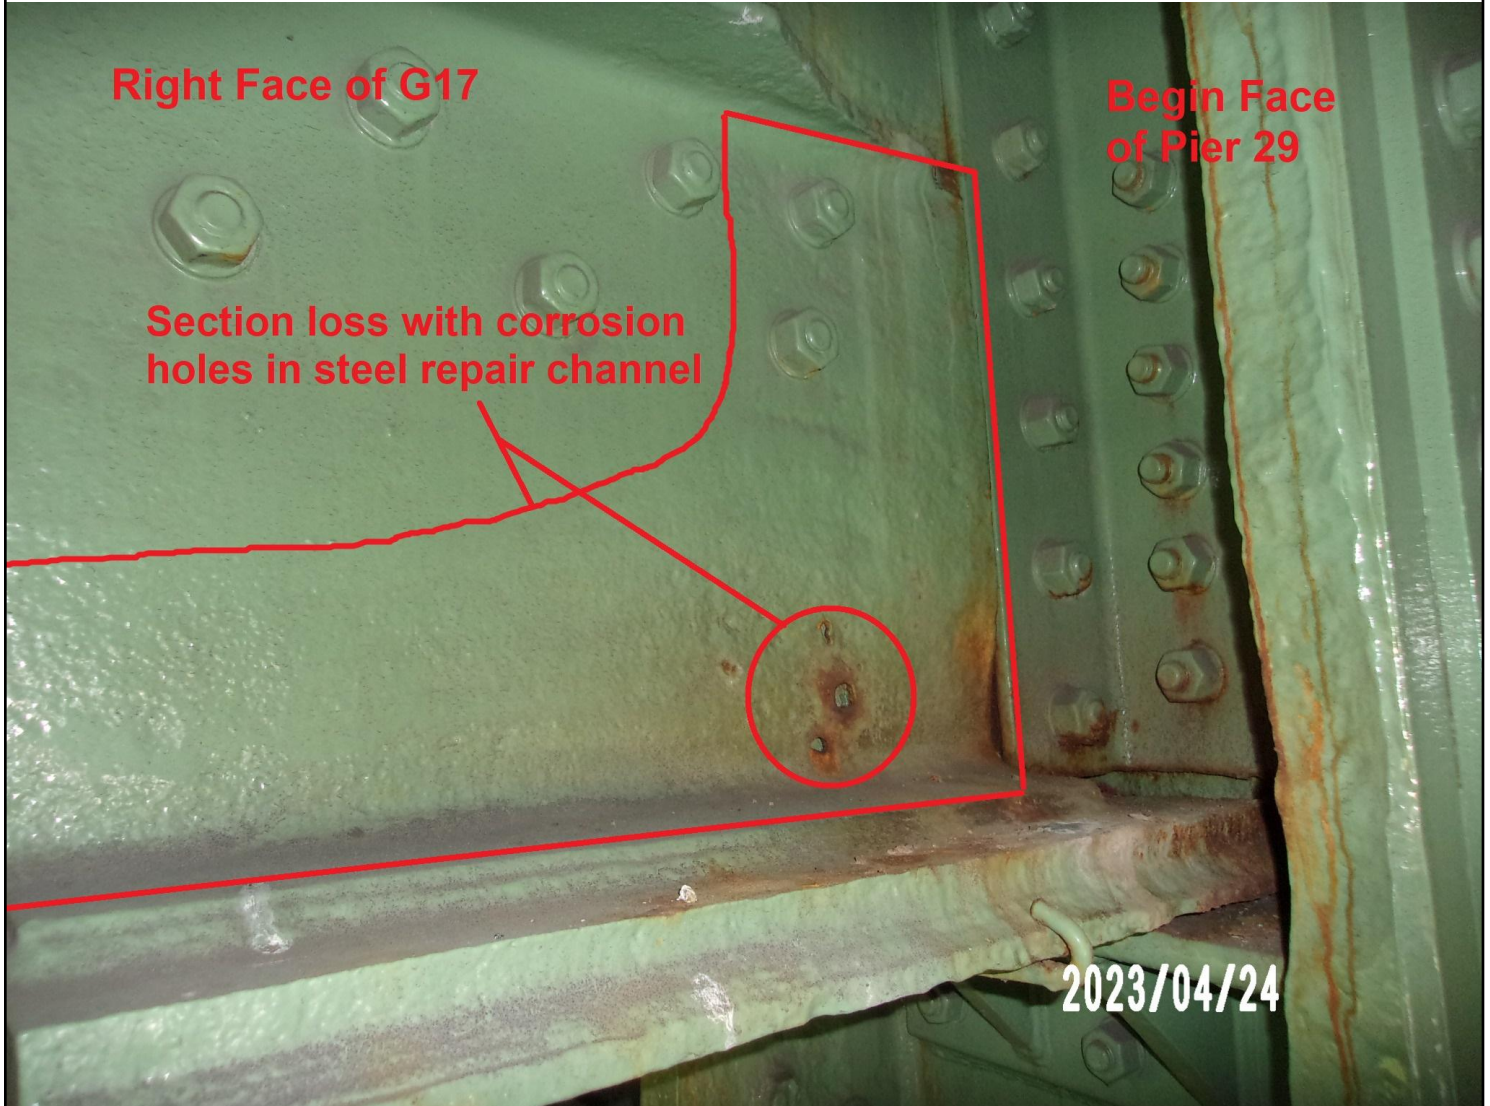
Photo Number: 9

Attachment Description: The right face of Girder G17 in Span 29 at Pier 29. The steel repair channel exhibits section loss with corrosion holes. Looking End and Left.

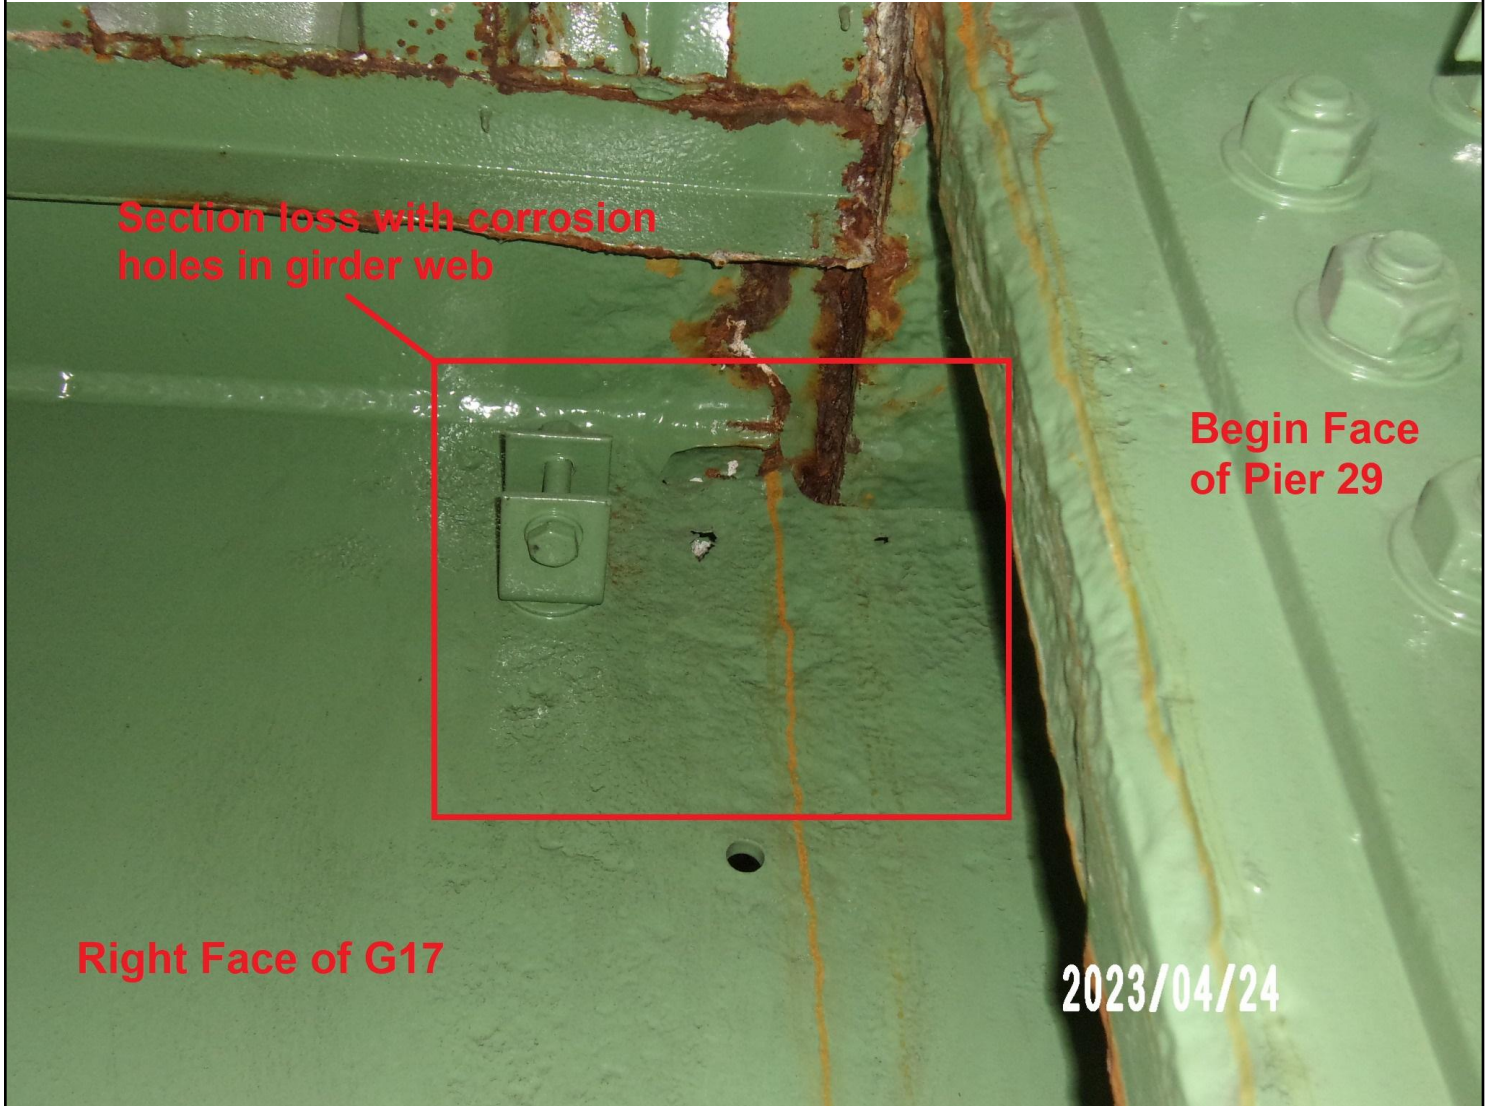
Photo Number: 10

Attachment Description: The right face of Girder G17 in Span 29 at Pier 29. The upper web of the girder exhibits section loss with corrosion holes. Looking Left.
